## Geotechnical Division Case Study SYC 12 miles, 1400 yards - Brick Kiln Lane, Whitchurch

### Sheet piling and embankment stabilisation works to remove speed restriction from a railway

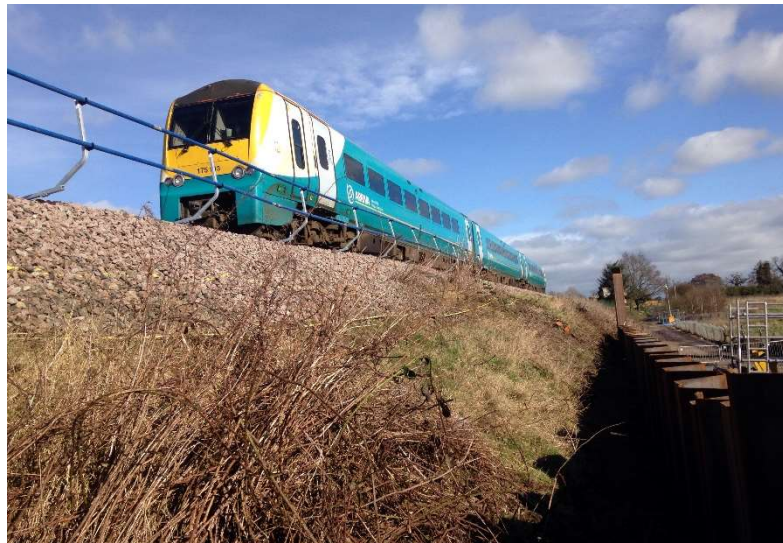
Fig 1) Train running on embankment whilst sheet piles are being installed.

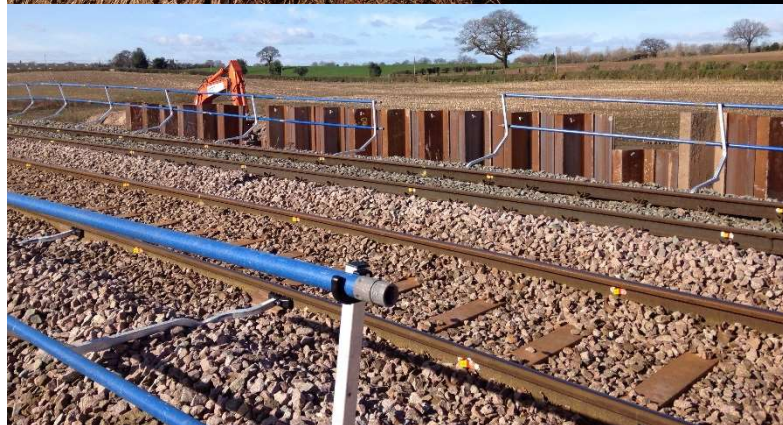
Fig 2) Sheet piles visible across the track prior to being hammered to level.

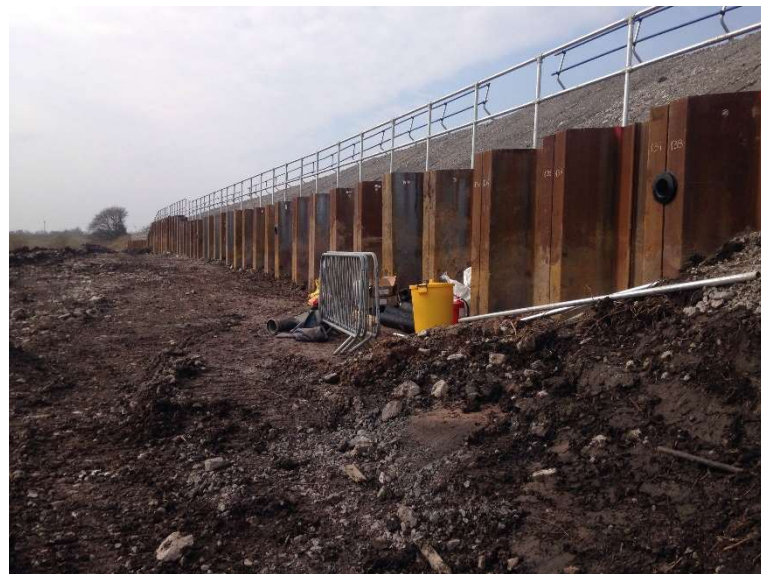
The site was a long-term track geometry problem site, proving very difficult to maintain line and level of the track. Regular maintenance to manually and mechanically lift, pack and tamp the track was required every few months over a period of 5 years. As a result of the track geometry problems a long-term temporary speed restriction was in place at 20mph on one line and 55mph on the other instead of permitted 75mph. Delay minutes and compensation associated with the speed restriction were resulting in significant costs which were not sustainable.

Up to 3m of soft alluvial and organic soils were found to be present in a depression which was present approximately at the centre of the site. Terrestrial flooding over geological time had filled a swallow hole associated with previous glaciation with soft soils – on top of which the railway embankment was constructed. Years of rail maintenance, ballast raising and tamping to correct the defect had simply fuelled continuous foundation extrusion and settlement within the soft underlying soils.

Pictured above:  
Fig 3) Original track defect with significant loss of geometry.  
Fig 4) Drilling works with 36T excavator on crest and 13T excavator on the toe.  
Fig 5) Completed sheet pile on one side of railway with regrade, safe cess, handrails and fencing.

A continuous sheet piled wall was designed for a length of approximately 100m to be installed at the toe of the embankment on either side of the embankment to cover the 40m problem area plus an additional length running the piles either side to ensure full foundation soil constraint.
