## Infrastructure Division Case Study Prior Park Dams

### Prior Park Landscape Gardens in Bath, owned and operated by the National Trust. Grade I listed, partially designed by Capability Brown

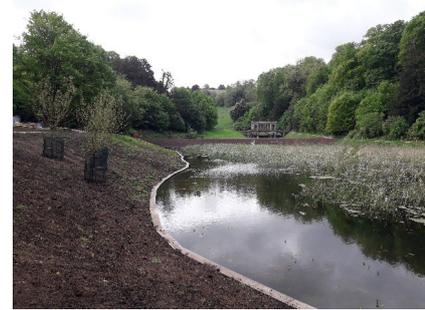
East Bank

American Signal Crayfish had eroded the middle dam and the embankment on the East side of the lower lake to such an extent that the dam was unsafe and the embankment eroded to a sheer face in places. The scope was to rebuild the middle dam and line the lower lake with plastic piling to prevent damage by crayfish and also to up-grade the lower outlet structure to be able to cope with a 1:10,000-year weather event.

Reconstruction of existing east bank with 1 in 3 downstream slopes and plastic sheet piles with timber cladding along downstream toe.

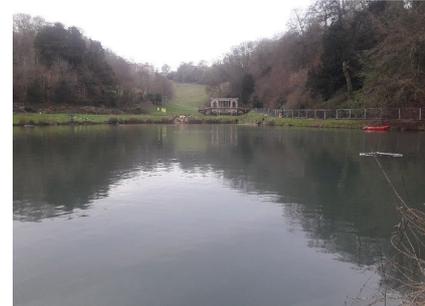
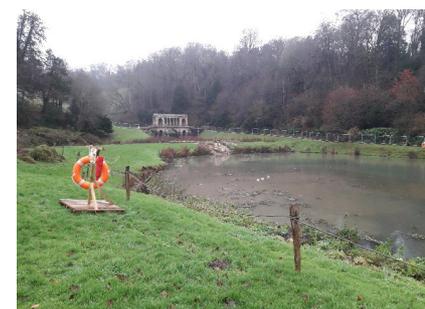
The middle dam was in poor condition and suffered failures resulting from voids within the structure, partly caused by non-native crayfish species burrowing into the banks. The middle pond was drained to reduce loading on the dam. The lower dam was found to have insufficient overflow capacity and would overtop in the design flood event, risking a potential failure. The National Trust were undertaking works to upgrade the middle and lower dams and restore the surrounding landscape.

Middle dam prior to works
