Geotechnical Division Case Study Cold Blow Drainage Resilience Works

As part of the Network Rail Wales Route Asset Management CP5 renewals works, Griffiths completed the installation of new crest, slope and track drainage throughout a 1.50km-long site in Cold Blow, Narberth.

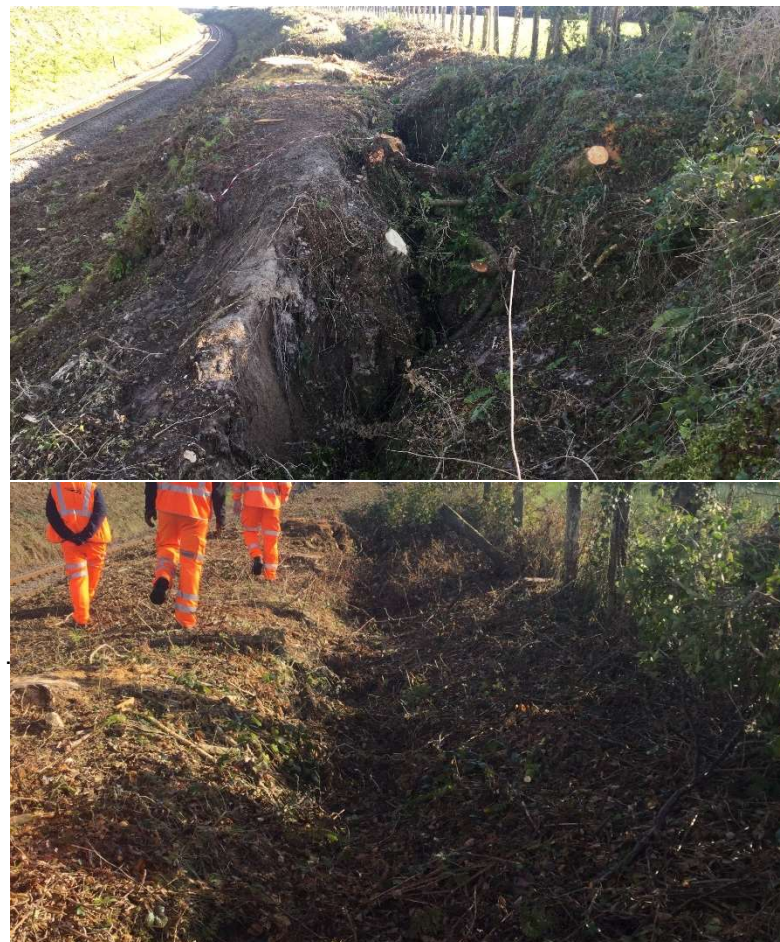
In the absence of a formal drainage system, the Cold Blow site had significant natural drainage features incised within the cohesive soil embankments throughout the section. These channels often carved deep, narrow trenches along the crest and down the middle of earthworks to allow water to drain to the lowest point. This carving of earthworks promoted further weathering and degradation of these, and also meant that repeated wetting and drying cycles of the cohesive soil gave rise to slumping and rotational failures. Furthermore, field drains from adjacent farmland concentrated water flows within specific areas of the site, further exacerbating the degradation of earthworks due to surface water.

Water drained from the earthworks would collect within the railway cess, with this draining in an unlined cess ditch parallel to track and towards topographical low points. Site topography varied significantly, with a high point near the centre of the section and track geometry falling steeply away from this in both directions. As such, water drained towards the North and South dependent on the location of drainage features within the site. Where flat spots or obstructions were present in the cess, water percolated through the track bed and trapped silt and other debris within the ballast. This ultimately led to significant wet beds and ballast contamination, requiring continuous track maintenance and repairs.

ABOVE: Views of the initial site conditions with no formal drainage systems, resulting in erosion of earthworks

In conjunction with Network Rail's in-house design team (NRDD), Griffiths were tasked with formalising the existing natural drainage features throughout the ~1.50km section of track, installing Concrete Canvas-lined drainage ditches, renewing existing track drainage and regrading significant trenches within earthworks.

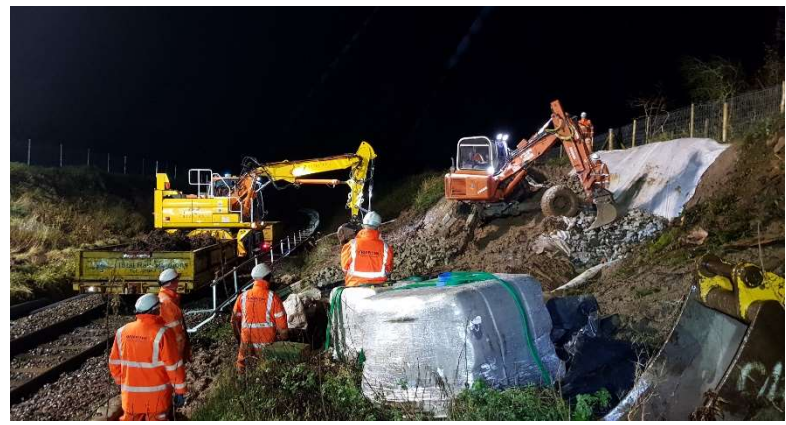
TOP: RRV and Spider excavator reprofiling existing downslope trenches to stable angles, installing perforated pipe and backfilling with 6G stone.

In discrete areas of the site, downslope incision of the earthworks by natural surface water drainage meant that these earthworks became unstable and were at risk of future slumping failures. These earthworks were of low height and with relatively stable slope angles (typically $<30^\circ$), therefore the outcome of failures was likely to be limited to slumping and washout contained within the cess, thus contaminating ballast and requiring continual track bed maintenance. Simple repairs to the localised area of incision and drainage enhancements were therefore required in lieu of full earthwork renewals. These repairs consisted of regrading the earthwork to a benched profile, lining the existing drainage feature with a perforated pipe and geotextile, and backfilling of this with granular fill. Effective compaction of typical earthwork fill materials within the site constraints and topography was not possible. As such, repairs were undertaken using 6G self-compacting fill to ensure effective repairs within the practicalities of construction and to ensure a safe construction sequence.

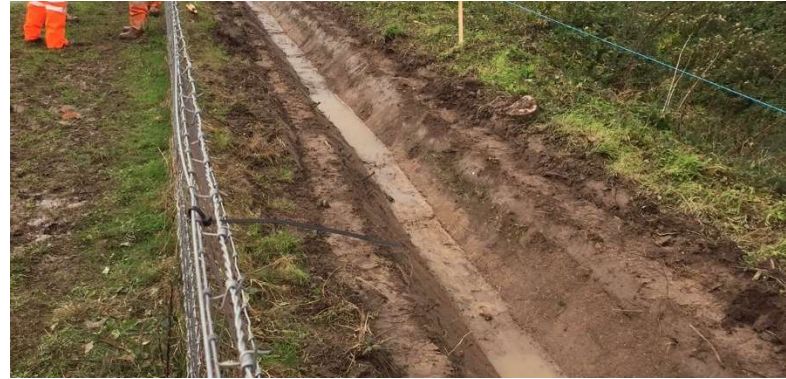
CENTRE: Progression concrete canvas ditches.

From off-track positions, a consistent V-ditch crest drain profile was excavated for the full length of site using 13t excavators. This was critical in ensuring a consistent fall was achieved within the entire drainage system. This involved a cut and fill exercise using specialist bucket attachments to utilise the existing natural drainage features within the earthworks. This allowed a straight alignment to be pulled through each of the natural crest and downslope drainage features at the site, ready for installation of Concrete Canvas. These features were then blended into the adjacent earthworks to ensure an aesthetic finish.

All crest and slope drainage features were prepared meticulously in accordance with the requirements of Concrete Canvas. Working in collaboration with representatives of Concrete Canvas, Griffiths were able to mitigate many of the potential issues experienced with this installation through effective preparation. This included creating a regular, uniform ditch profile, clearing voids and sharp obstructions and utilising an effective anchor trench for canvas ends. Griffiths drainage specialists then installed Concrete Canvas using large batch rolls, serviced by excavators from off-track positions within the adjacent farmland. This resulted in an excellent standard of installation under normal rail operating conditions without requirement for possessions or passenger disruption.

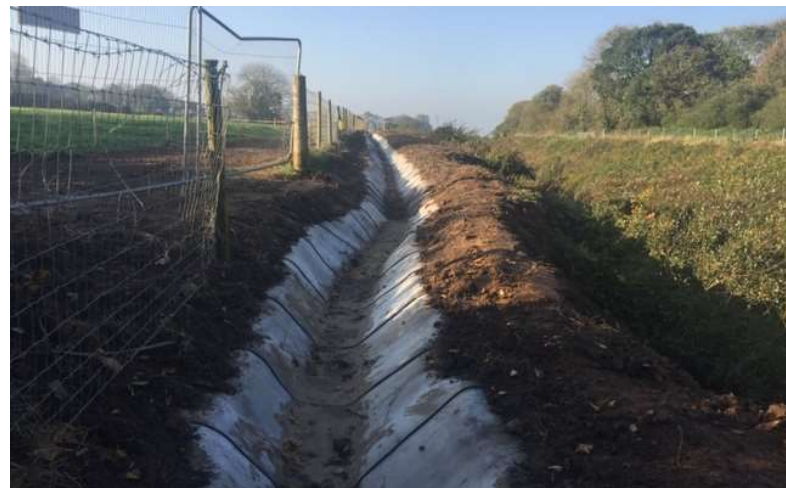
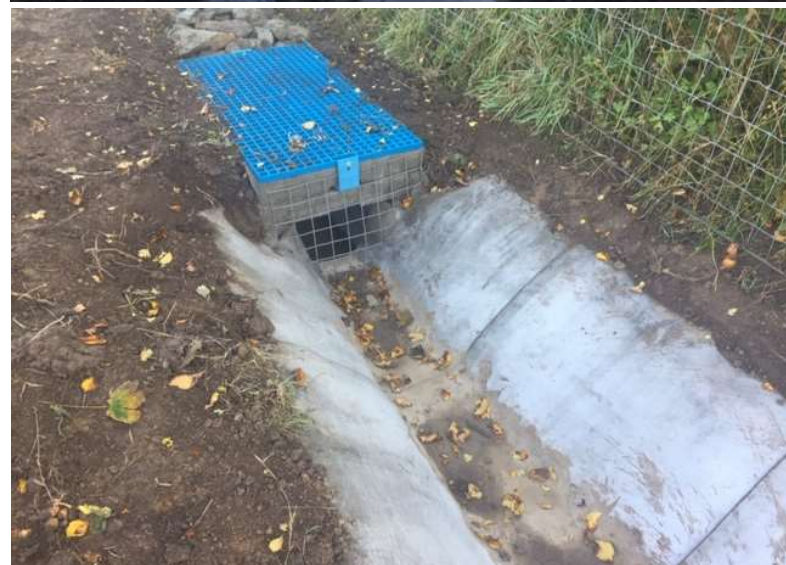
BOTTOM : Finished project, showing effective installation of concrete canvas drainage systems and catchpits.

Finally, cess ditches were reprofiled and protected with ballast retention to ensure effective drainage of all surface water away from the track bed. All features were successfully installed prior to the winter months, enhancing the resilience of this route section.
