Geotechnical Division Case Study Capel y Ffin Emergency Works

Following a landslide along the critical rural route between Abergavenny and Capel y Ffin, Griffiths worked in collaboration with Monmouthshire County Council and Capita to deliver a safe and effective emergency solution in March 2022

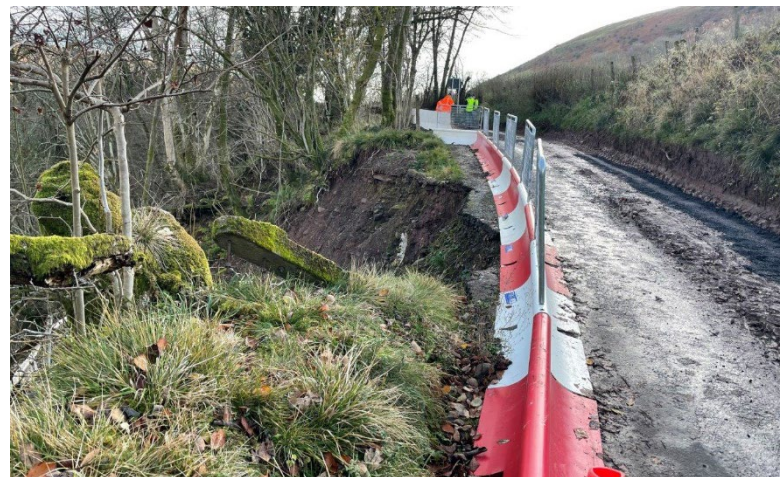
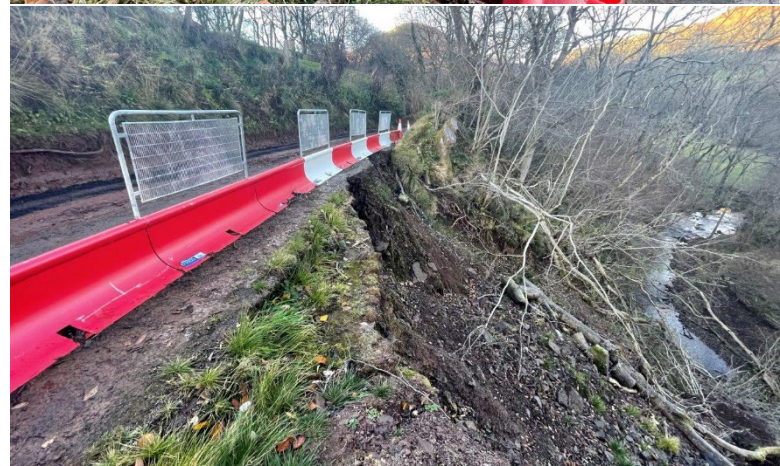
Initial findings suggested that surface water run-off had repeatedly saturated the downslope area, thus causing the landslide. The limited vegetation coverage in adjacent fields and absence of carriageway drainage systems were amplified by the prevailing topography, directing surface water down towards the carriageway. The camber of the carriageway itself further promoted surface water to concentrate in isolated areas of over-the-edge drainage.

Pictured above: Views of the initial landslide from North and South perspectives, showing undercutting of carriageway.

The design solution included installing a series of soil nails and erosion control netting system within the failed down-slope area. These were designed to support the road and to improve the resilience of the exposed failure, preventing further loss of carriageway. An edge beam detail consisting of anchored gabion baskets was also installed along the down-slope edge of the carriageway to prevent further degradation of the road verge. Regrading of the up-slope side of the carriageway was undertaken to increase carriageway width and move the carriageway edge away from the failure. This regraded slope was covered with erosion control matting to prevent soil erosion and assist in vegetation re-growth. Finally, surface water drainage ditches were installed along the crest and toe of the up-slope side to intercept and direct surface water away from the site towards major drainage outfalls to the North and South of the section.

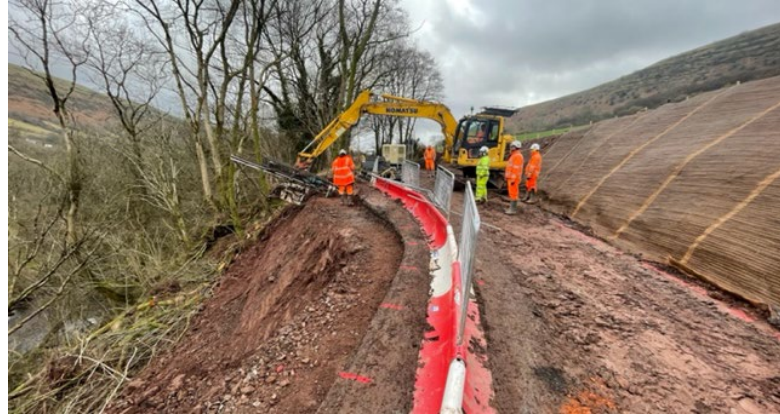
TOP: 13t excavator installing first row of nails for anchored gabion baskets by Griffiths roped access operatives.

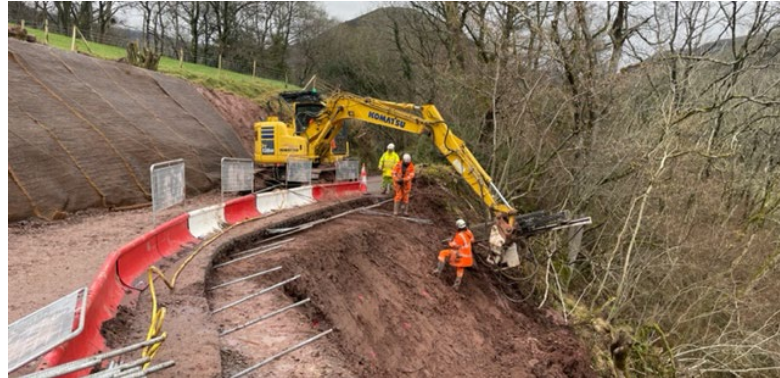
CENTRE: Griffiths geotechnical specialists undertaking investigation test nails to inform the Permanent Works Design.

Alongside the main construction work, Griffiths undertook a series of investigation and acceptance tests on various sacrificial and production soil nails to determine the capacity of ground anchorages within site geology. These direct tests were specified in conjunction with both Designers requirements to ensure that the results verified the initial construction and could also be used to inform the later enhancement works. These results could be combined with topographical site data, investigation information and other site observations to determine the most efficient anchorage arrangements and length for the permanent solution. This will lead to a direct cost saving to the Client through utilising similar construction methods and solutions.

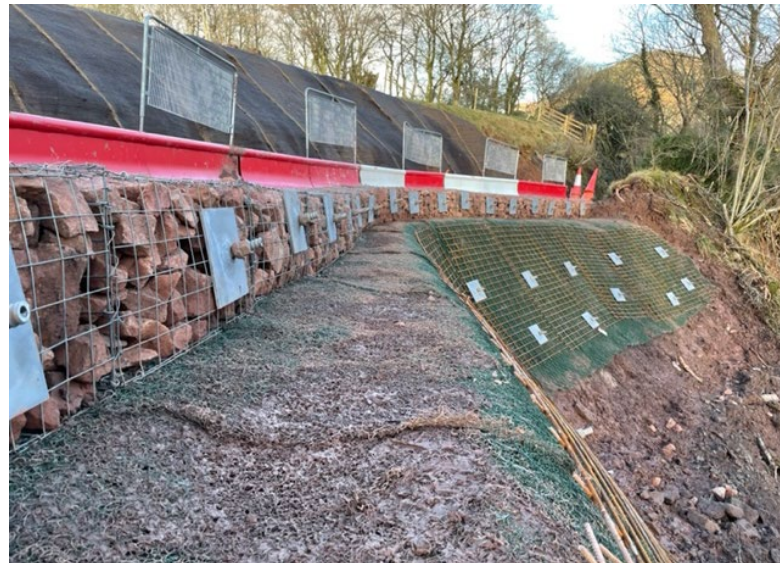
BOTTOM : Finished project, safeguarding the road against further failure and degradation prior to construction of a future enhancement scheme.
