Geotechnical Division Case Study Llwyncelyn Road Embankment

Remediation of a 170m section of existing failing embankment adjacent to the B4278 Llwyncelyn Road, Porth, Rhondda Cynon Taf (RCT).

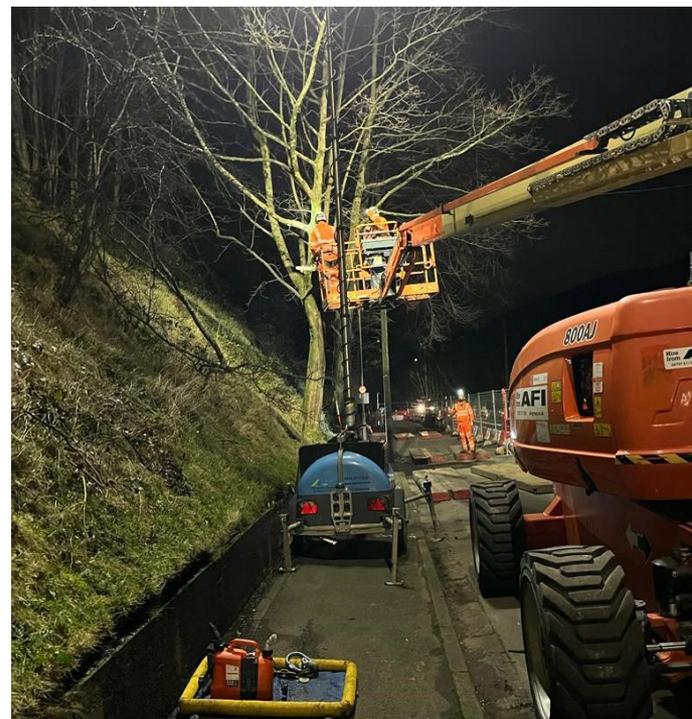
Pictured above: Griffiths NPTC trained operatives removing 1 of 14 mature trees using a MEWP

The remediation works involved removal of 14 No mature trees, minor regrading of the embankment surface, installation of rock anchors/soil nails and netting systems throughout the embankment surface, construction of a reinforced concrete capping beam linked to the existing retaining wall, installation of new drainage systems behind the wall and a key clamp fence installed on top of the wall for future maintenance works.

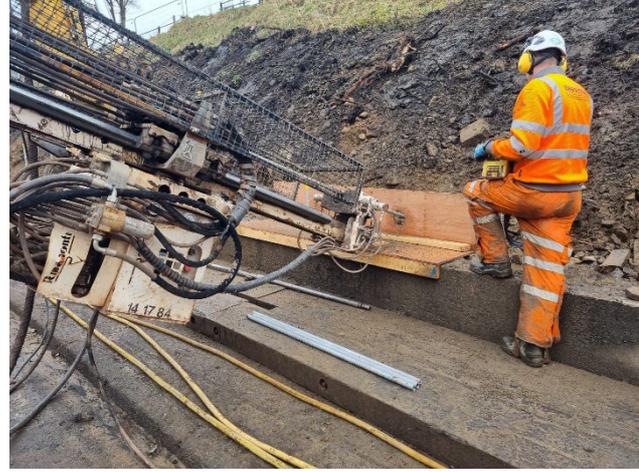
TOP: Griffiths Geotechnical Staff installing Soil Nails into the failing slope.

Utilising the existing structure as a foundation, a series of rock bolts and soil nails would be installed at the rear of the wall linked to steel rebar and vertical stainless-steel dowels to prevent rotational failure of the new capping beam.

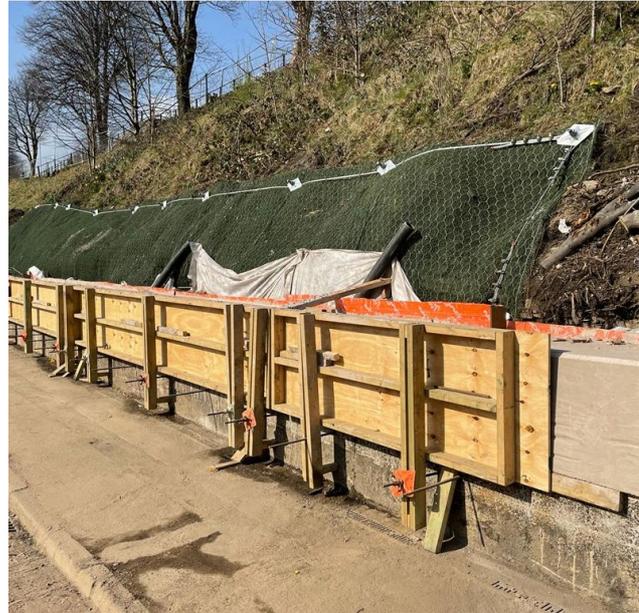
CENTRE: Falsework and Formwork used to construct new capping beam

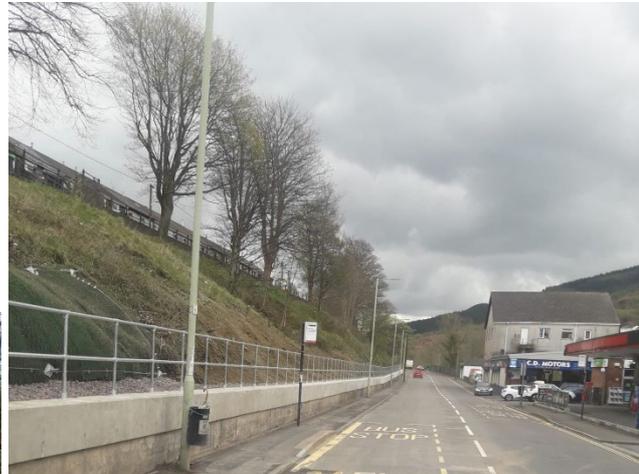
BOTTOM: Completed works including Key clamp fence detail for future maintenance of the embankment.
