## Geotechnical Division Case Study Pont Herber Fechan

### Soil nailing, embankment reinstatement and erosion prevention works to the River Ceiriog

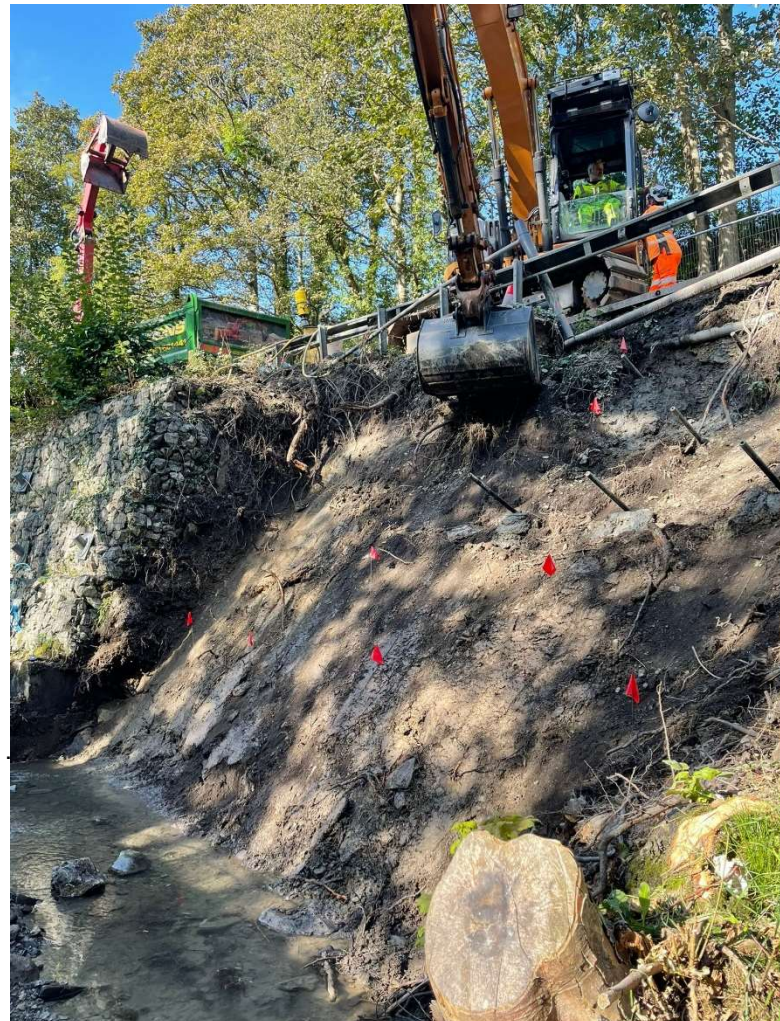
Pictured above: view of embankment reprofiling, removal of slip and installation of soil nails, working with a dam to control river levels.

The works consisted of the removal and regrade of the existing slope back to competent material. This was completed using a 13T excavator from road level. The excavator was placed on bog mats to spread the load of the plant and prevent further slope instability from occurring. Care was taken around the existing vehicle restraint system (VRS), BT and water services. Pump extracted water from the dig was passed through a silt buster system before being returned to the river downstream of the worksite.

The slope was stabilised with 54No. 38mm diameter soil nails, up to 9m long, installed in a 76mm bore. Works were progressed using a long reach 13T excavator, allowing the nails to be installed such that the loading from the excavator was not directly above the most vulnerable areas of the slope until they had been stabilised. All grouting works for the soil nails were completed within a proprietary bund system to prevent loss of grout to the river and potential pollution. Griffiths employed an emergency plan for the works, had a pollution boom ready strung across the river to be lowered if necessary and had liaised with local downstream fisheries to be able to shut off penstock intakes in the event of an emergency.

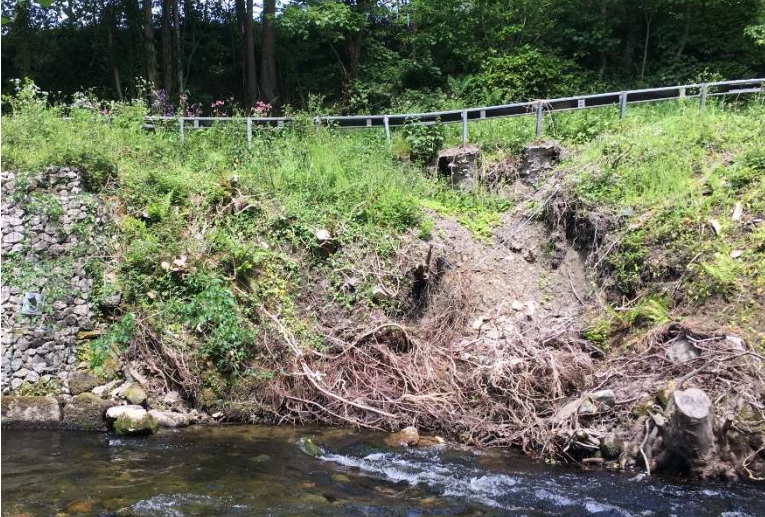
Pictured above:  
Fig 1) Original erosion, slip and loss of shoulder support to road above.  
Fig 2) Full completed works from road level showing VRS and drainage works.

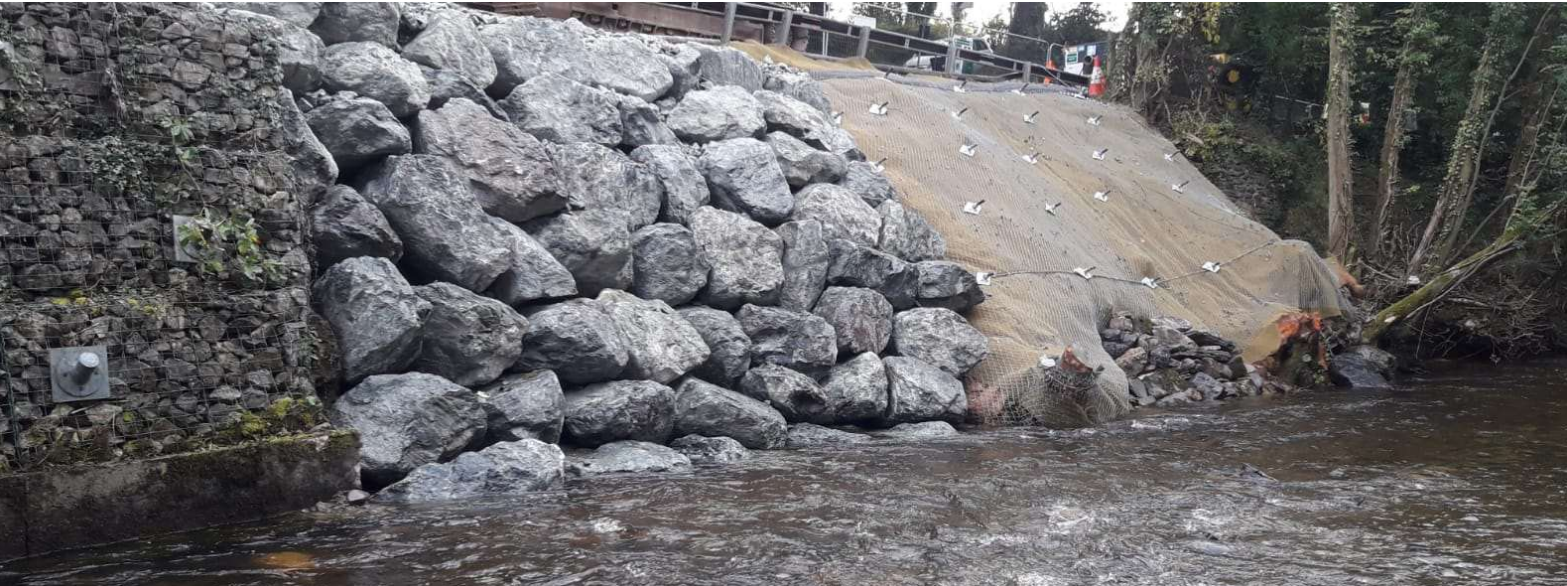
Pictured above:  
Panoramic showing reinstated riverbank, with soil nailing, mesh and rip rap.

Erosion control matting consisting of a 3D matrix and coir matting were pinned to the slope prior to the placement of a high tensile steel mesh known as TECCO. The system was finished with boundary wire ropes and tensioned to 5 ton to provide active restraint to the face.

Once the slope had been stabilised Griffiths utilised a 21T long reach excavator with zero tail swing from WM Plant Hire together with grab attachment. This allowed a larger excavator with greater lifting capacity to be used, even when working with a very narrow lane closure. The excavator was used to place rip rap stone, weighting up to 2T a piece. The stones were embedded into the river channel and arranged to fill the hollow resulting from the original slope failure, allow the crest to be reinstated and a transition to be installed between the soil nailed solution and the historic hard engineered gabions adjacent. All in river works were completed by the fish spawning season embargo with no pollution incidents.
