## Rail Division Case Study **Little Haglow Emergency Works**

**When a transitional slip failure near Lydney in Gloucestershire closed the SWM2 between Newport and Cheltenham Spa, Network Rail IP Wales turned to Griffiths to conduct emergency cutting remediation works to allow the busy freight line to be reopened just three days later.**

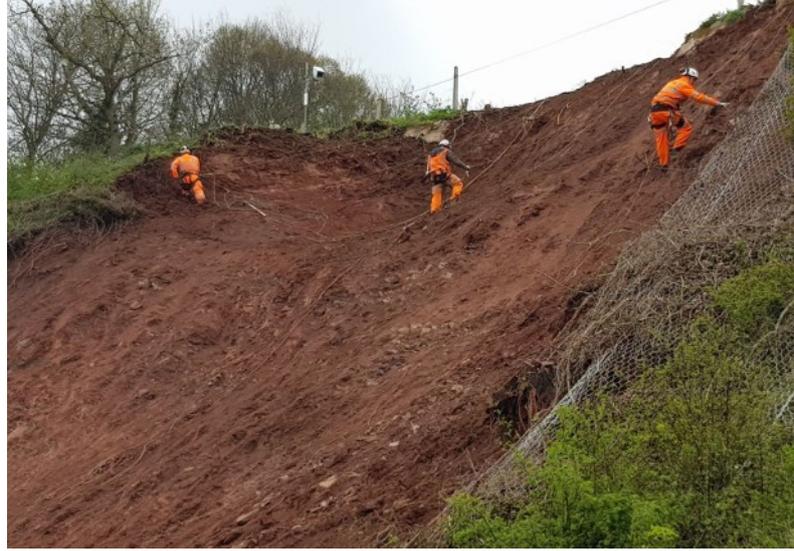
TOP: IRATA trained operatives descending the slope and dislodging loose material.

Removal of the existing netting over the slip required rope access operatives to descent either side of the slip while cutting the netting using disc-cutters. Once this was done the excavator cut the main 16mm vertical cables allowing the freed netting to be gathered ready for removal.

Following this, one of the long-reach excavators was deployed at the crest of the embankment to 'push' loose material down, while the other was located at the toe to 'pull' material towards the bottom of the embankment. Benching using gathered material allowed the lower excavator to work progressively higher up the slope. IRATA qualified rope access operatives were tasked with descending the slope and dislodging any remaining material using picks and bars. Once this was completed the spoil was loaded into the 18 wagons for transfer away from site.

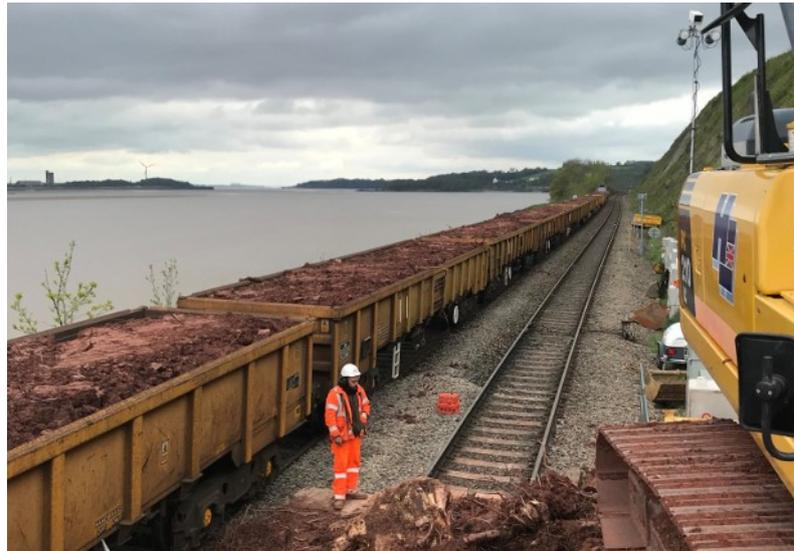
CENTRE: Spoil from the site is loaded into 18 wagons for transfer away from the site.

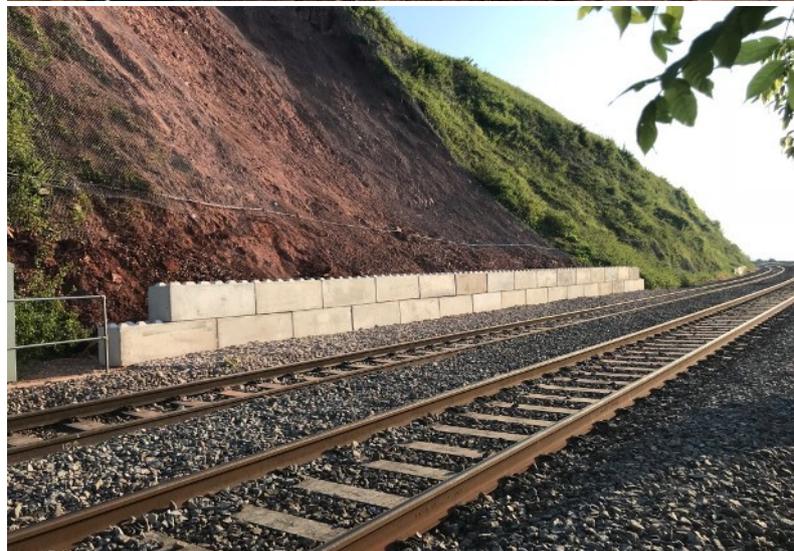
BOTTOM: Precast concrete Legato blocks are used to create a wall at the toe of the embankment as a protective barrier against further material falling onto the track.

The final stages of the work included the positioning of 35 precast concrete Legato Blocks to create a wall along the toe as a protective barrier against further material falling, and the installation of temporary drape netting.
