Geotechnical Division Case Study Tylorstown Landslide Remediation Phase 3A

Project details at a glance

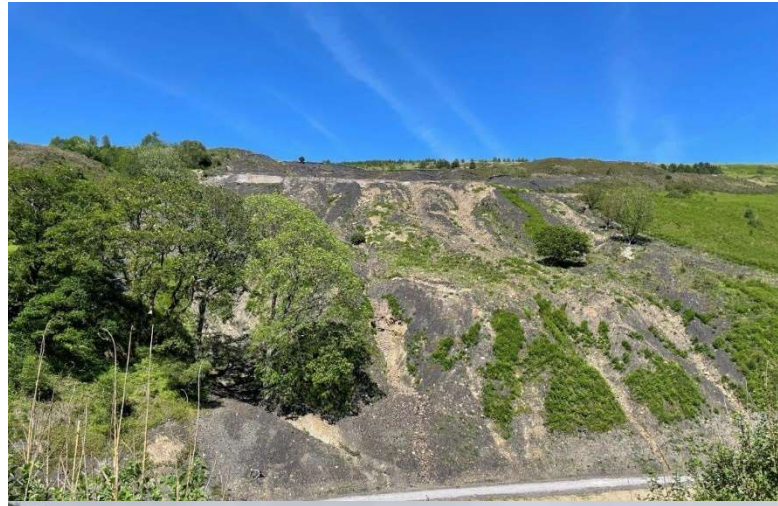
TOP: Site conditions prior to works commencement

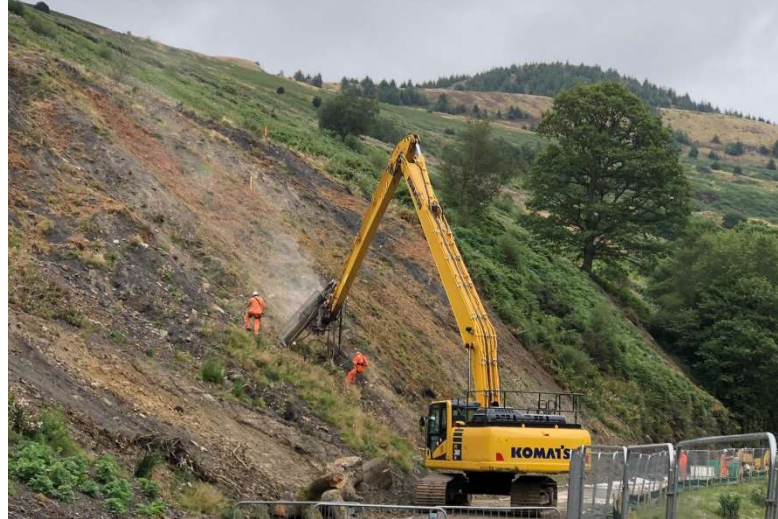
CENTRE: Mechanised drilling using heavy plant

Drainage works previously undertaken at the site had assisted in reducing the causative factors of a repeat event, however the residual risk exposure required further management. On-slope works were avoided in the first instance by using long reach excavators, mounted with drilling equipment and positioned from the cycle path. These worked at a slewed angle to prevent being positioned directly beneath the activity. Tiered/managed exclusion zones were implemented as part of the Griffiths Geotechnical bespoke Permit to Drill system, outlining areas of total exclusion and safe walkway areas. Where work on the slope was unavoidable, suitable plant secured to bespoke, purpose-built Temporary Works support/tethering systems were utilised. Appropriate rescue systems and methods were developed by the Griffiths Geotechnical in-house IRATA division, ensuring safe systems of work were maintained throughout the construction phase.

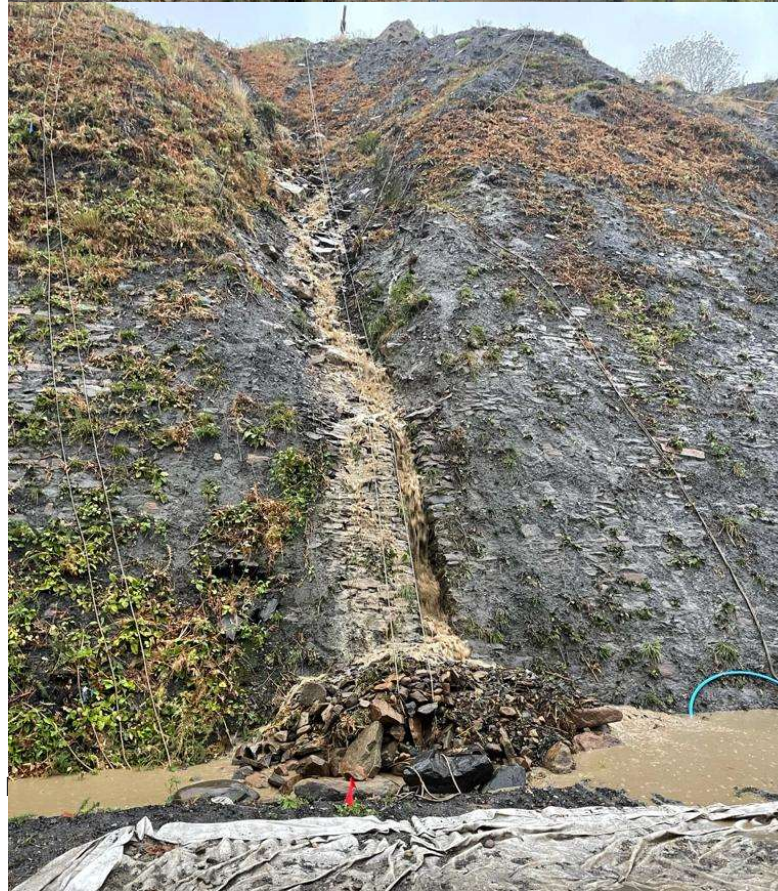
BOTTOM: Example of debris flows during construction

Whilst no further landslides of the colliery tips were recorded during the construction phase, significant debris flows occurred during yellow weather events of September and October 2021. These events, caused by intense rainfall, mobilised a significant amount of material. This was channelled downslope towards to the worksite by the incised slope topography. Griffiths Geotechnical were successful in identifying these events immediately, evacuating the worksite and developing a new safe method of construction and rescue without significant delay to the construction programme. All works were safely and successfully completed in November 2021. The project received significant media attention and Griffiths Geotechnical were proud to have assisted in providing the local community with additional safeguards against the hazardous legacy of coal mining in South Wales.
