## Infrastructure Division Case Study Prior Park Dams

### Prior Park Landscape Gardens in Bath, owned and operated by the National Trust. Grade I listed, partially designed by Capability Brown

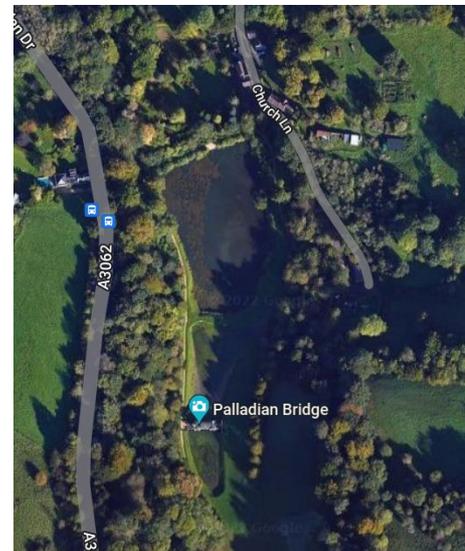
The gardens have three ponds, impounded by the palladian bridge, middle dam and lower dam respectively.

The middle dam was in poor condition and suffered failures resulting from voids within the structure, partly caused by non-native crayfish species burrowing into the banks. The middle pond was drained to reduce loading on the dam. The lower dam was found to have insufficient overflow capacity and would overtop in the design flood event, risking a potential failure. The National Trust were undertaking works to upgrade the middle and lower dams and restore the surrounding landscape.

The works to the Middle Dam consisted removal of outlet and cascade, replacement of existing dam with new clay core and compacted selected fill with 1 in 3 downstream slopes. New sheet pile cut-off below the dam core on the western limb; Raising of embankment level by 0.2m-0.3m to bring it to a consistent level. The repair of upstream masonry wall and construction of new where no existing wall was present; The construction of new letterbox weir and cascade with stone cladding, the construction of a new outlet pipe and arched culverted outlet, with stone cladding; path and embankment detailing and plastic sheet piles with timber cladding along downstream toe.

Works to the Lower Dam consisted of removal of the existing structures; construction of a new outlet structure with stone cladding to increase overflow capacity, raising the embankment crest level by 0.6m-0.7m, path and embankment detailing and reinstatement of stilling basin and associated works.

Reconstruction of existing east bank with 1 in 3 downstream slopes and plastic sheet piles with timber cladding along downstream toe.
