GRIFFITHS

Rail Division Case Study Rebuilding and Future Proofing the Conwy Valley Railway

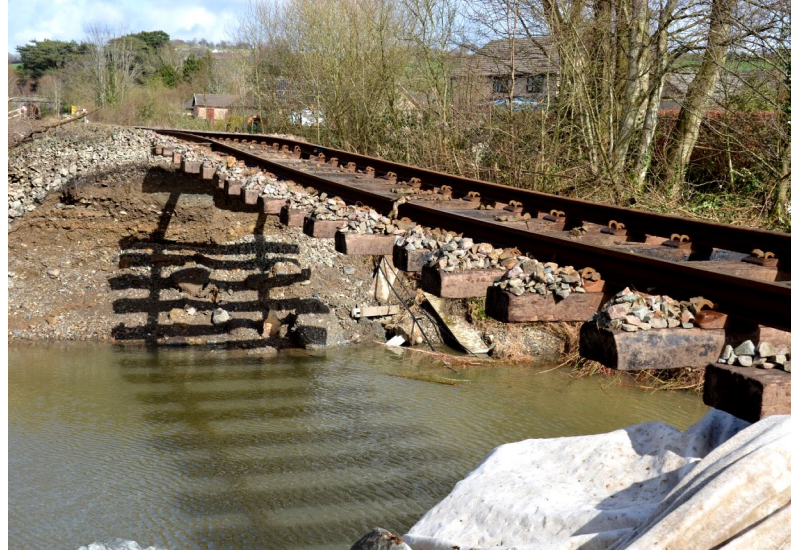
TOP: Following the extreme weather event, detailed inspections revealed multiple sections of track, lineside equipment, embankments, bridges, level crossings and stations required significant repairs.

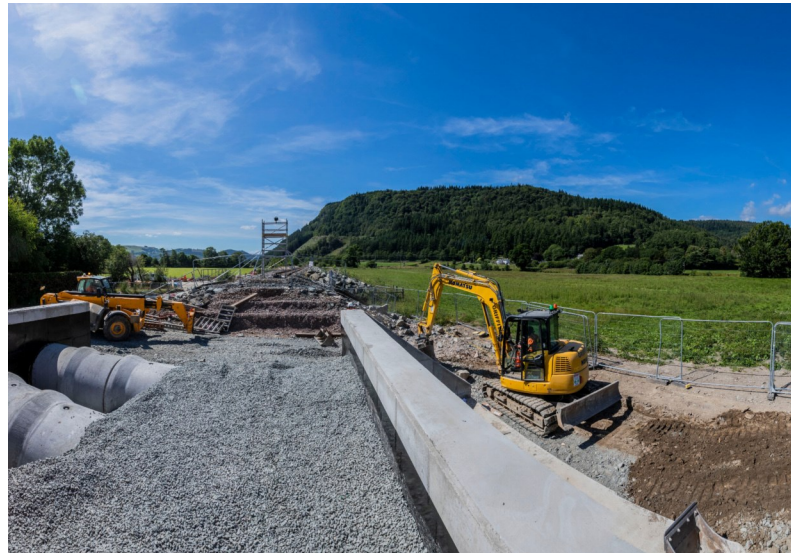
CENTRE: Works included the restoration of nine culverts, designing and building new improved culverts, constructing new embankments and installing new track.
